ENVIRONMENTAL EFFECTS ON  
DEFECT GROWTH  
IN COMPOSITE MATERIALS

by  
T. R. Porter

Advanced Airplane Branch  
Boeing Military Airplane Company  
A Division of The Boeing Company  
Seattle, Washington

NASA Lewis Research Center  
Contract NAS3-20405  
Gordon T. Smith, Project Engineer

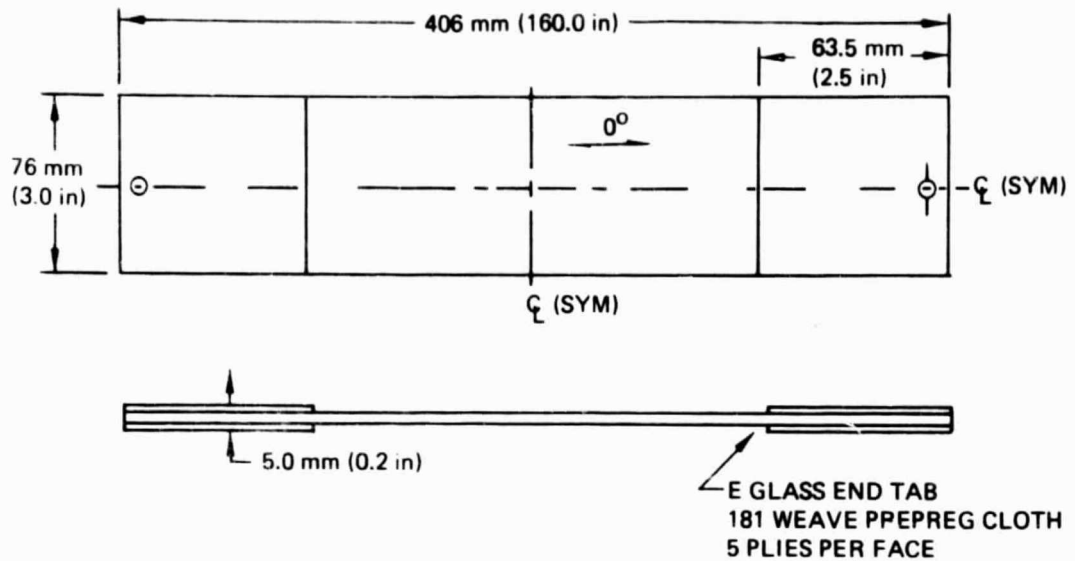
Figure 1. Test Specimen Configuration

The test specimen configuration is shown in figure 1. The 76-mm (3.0-in) width used for the majority of the tests was chosen to provide specimens large enough to preclude significant interaction between the stress concentration and stress-free specimen boundaries. The specimen was designed so that the stress concentration factor for the largest defect would be within 5% of the corresponding stress concentration factor for a plate of infinite width. The potential effect of the free edge on the fracture behavior was investigated experimentally by static testing specimens of various widths that contained the largest defects. The  $0^\circ$  laminate direction corresponds to the axial direction of the specimen. Woven fiberglass grip tabs were secondarily bonded to the specimen using a 394K (250°F) cure adhesive.

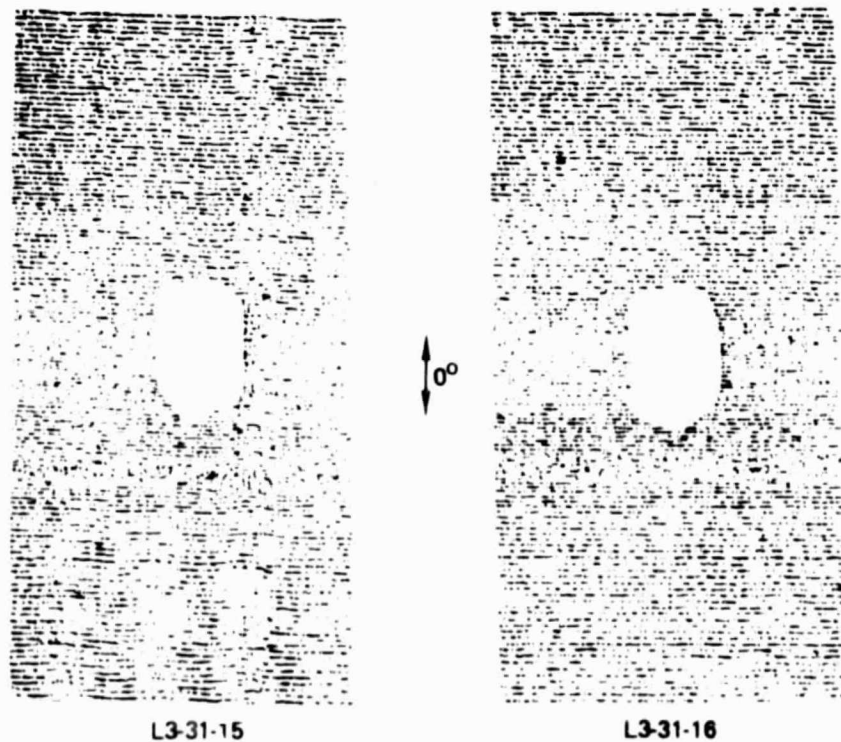
Figure 8. Ultrasonic Scan Records for Impact Damage

LAMINATE LI SPECIMENS  $[(0/\pm 45/0/90)_S]_2$

LAMINATE L3 SPECIMENS  $[(0/+30/0^\circ/-30/0)_S]_2$

The impact damage defect was produced by impacting the specimens with a 0.91 kg (2 lb) weight dropped from a height of 0.38m (15 in). Figure 7 is a photograph of the impact stand used. The test specimen was supported on a circular support containing a 15.9-mm (0.625-in) diameter hole. This support condition, together with the 15.9-mm (0.625-in) diameter hemispherical impactor, produced delamination damage areas approximately 15.9 mm (0.625 in) in size. Examination of sectioned specimens damaged in this manner showed delamination damage throughout the laminate thickness. Ultrasonic C-Scan records of typical impact-damaged test specimens are shown in figure 8.

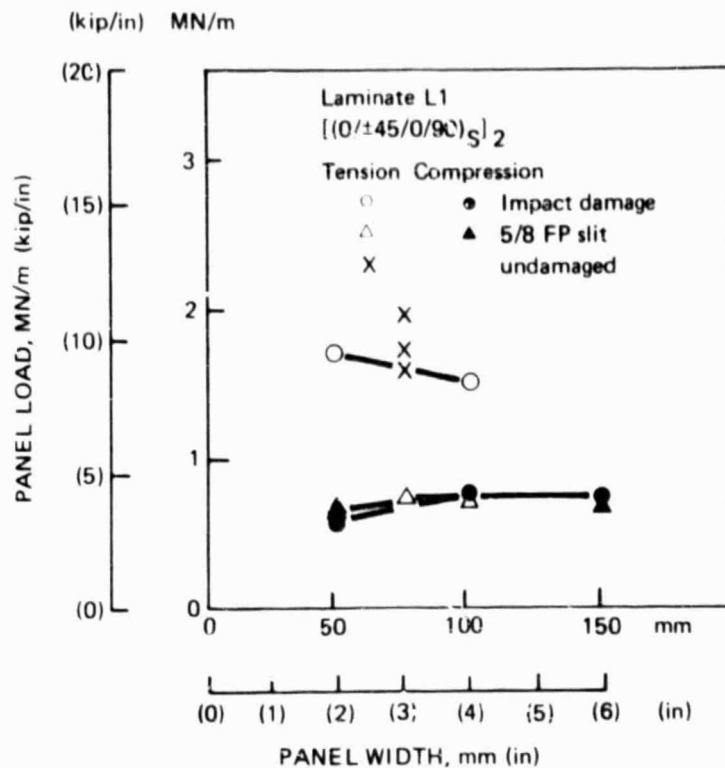
Figure 9. Effect of Width on Static Strength of Laminate L1

The results of the width effect testing are shown in figures 9 and 10 and presented in appendix B. These data are normalized to load-per-unit width to allow a direct comparison of the various panel widths. Previous test data are also included in the figures where applicable. The trends found are similar for both the L1 and L3 laminates and similar conclusions are applicable to each.

At widths of 100 and 150 mm (4.0 and 6.0 in) there is no significant width effect shown by the data. At the 50-mm (2.0-in) width, there is a slight decrease in strength. The 76-mm (3.0 in) specimens are similar to the 100- and 150-mm (4.0- and 6.0-in) specimens. It is concluded that the selection of the 76-mm-wide test specimen size was sufficient for the largest defect size tested.

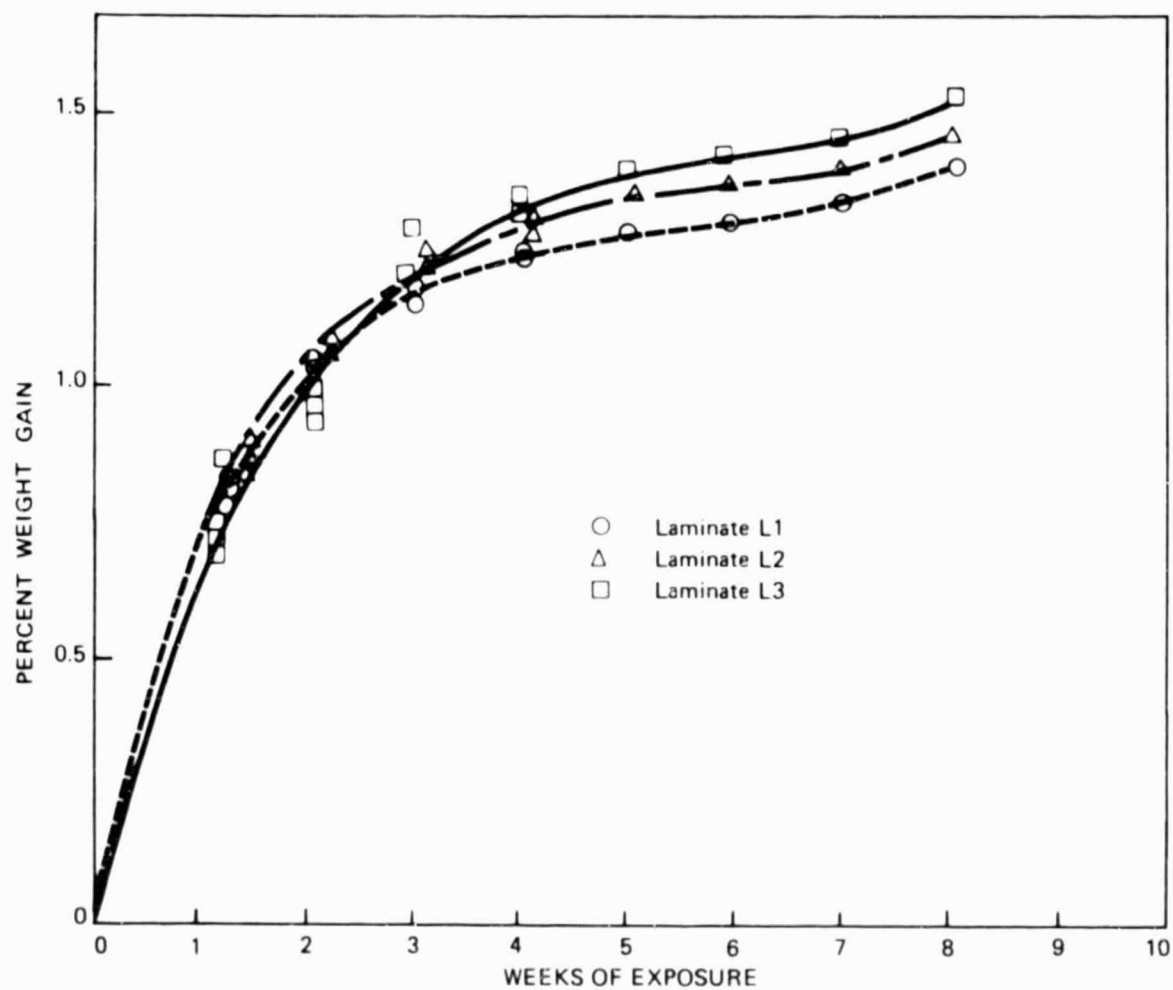
Figure 13. Weight Gain in Untabbed Static Test Laminates

The weight-gain data found for the untabbed laminates conditioned with the static test specimens is shown in figure 13. As can be seen, the final moisture level is about 1.4% to 1.5% by weight in all laminates. Laminate L3, which contains four plies of glass fiber, has the greatest final moisture content.

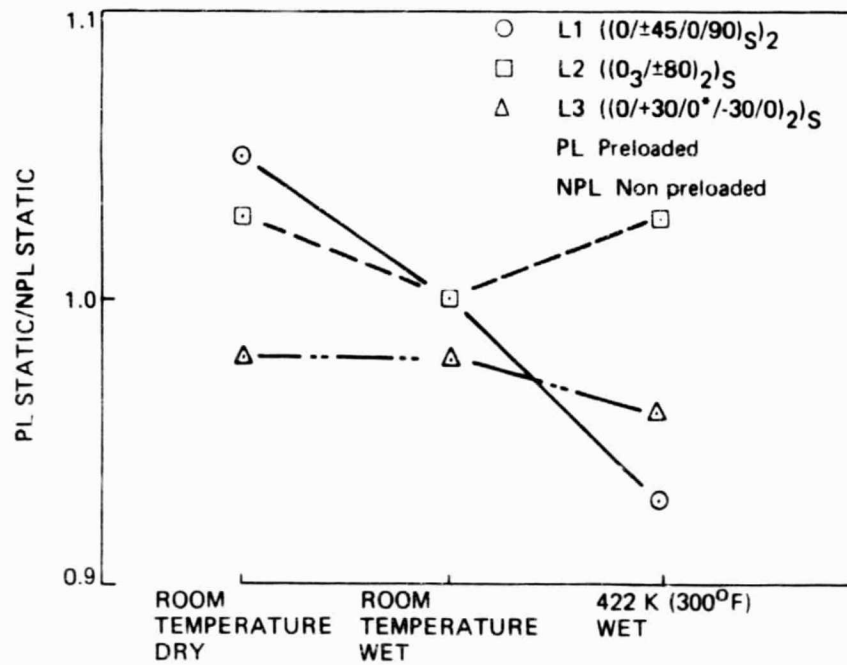
Figure 42. Average Ratio of PL to NPL Specimen Fracture Strength

Defect code	Ratio of Preload (PL) to Non Preload (NPL) static strength											
	Laminate L <sub>1</sub>			Laminate L <sub>2</sub>			Laminate L <sub>3</sub> hybrid			Laminate L <sub>3</sub> all graphite		
	Room		422K	Room		422K	Room		422K	Room		422K
	Dry	Wet	Wet	Dry	Wet	Wet	Dry	Wet	Wet	Dry	Wet	Wet
FP SLIT	1/8	1.11	1.02	0.92	1.01	1.24	1.02	0.99	1.06	0.89	0.94	
	3/8	1.01	1.08	0.89	0.97	1.05	0.99	1.00	0.98	0.81		
	5/8	1.04	1.08	0.89	0.92	0.94	1.08	0.97	0.98	0.98	0.91	0.89
FP HOLE	1/8	1.10	1.00	0.96	1.00	1.04	1.05	0.98	1.00	1.03		
	3/8	1.12	0.99	0.79	1.08	0.93	1.01	1.04	1.01	0.81		
	5/8	1.08	1.06	0.83	1.19	0.90	1.07	—	0.92	1.00	0.97	0.91
HP SLIT	1/8	1.12	1.00	0.82	1.19	1.03	0.99	0.95	0.97	0.93		
	3/8	1.17	0.90	0.97	0.92	0.93	1.00	0.93	1.12	0.93		
	5/8	1.05	1.19	0.90	—	0.99	1.07	—	0.75	1.23	1.05	0.88
HP HOLE	1/8	0.95	0.92	0.87								
	3/8	—	0.90	0.93								
	5/8	0.96	0.92	1.07								
CSK HOLE	1/8	1.03	0.90	1.02

3/8	—	1.11	1.05								
	5/8	1.09	1.00	0.87								
NONE	—	0.99	0.91	0.99	0.98	1.04	0.95	0.96	0.95	0.95
